# Lessons Learned From an Unusual Hydrogen Reformer Furnace Failure

Mike Rogers, Syncrude Canada Ltd. Fort McMurray Alberta Canada

On January 30, 2005 a high-energy pressure impulse occurred within several radiant tubes of a steam/ methane reformer furnace during startup after a partial shutdown. This impulse caused the simultaneous rupture of 5 tubes with sufficient force to eject portions of the tubes out through the roof of the furnace. All of the failures occurred near the inlet of each tube in the headspace above the catalyst and the 5 tubes were clustered toward the centre of the furnace in four rows.

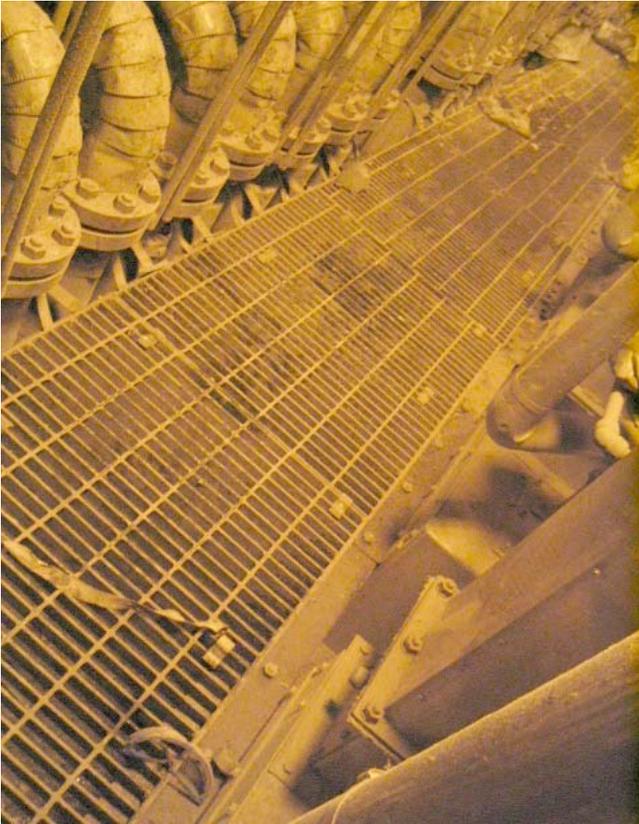
**Photograph 1** General arrangement radiant tube inlets

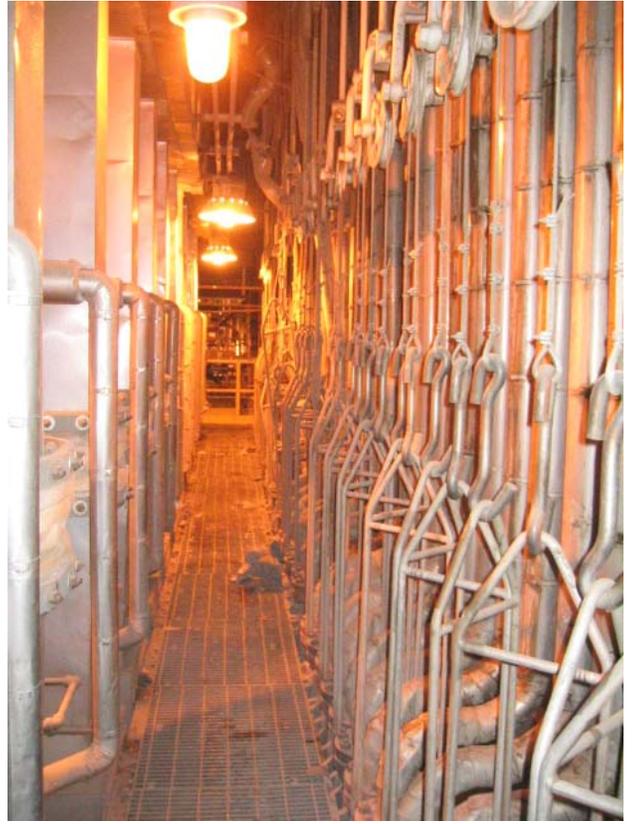
**Photograph 2** Pre incident general radiant tube arrangement

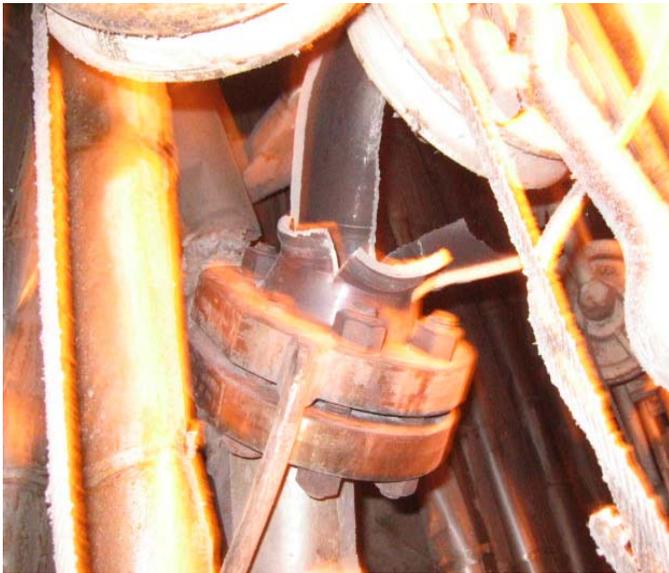
Photographs 7 and 8 detail one of the 5 tube failures

**Photograph 7** Tube # 116

The five tubes noted above as having had their upper ends grossly lifted exhibited unique fracture features.

All of these tubes showed complete mechanically brittle circumferential separation on multiple planes of the tube material between ~14cm to 45cm (~0.5 ft to ~1.5 ft) below the flange. The different planes of circumferential cracking were bounded by mechanically brittle (no local distortion) longitudinal cracks running toward the flange. This indicates that longitudinal cracking preceded circumferential cracking. In many cases, the remaining material between the longitudinal cracks was highly deformed radially. Longitudinal cracking generally arrested in or near the flange hub and was sometimes accompanied by circumferential tearing at this point. Some large pieces of shrapnel found on the furnace roof believed to have come from this region of these tube assemblies also exhibited significant distortion in some areas and very little in others. Whether this distortion occurred before or after separating from the tube is unknown. Hence, the extent of distortion and longitudinal cracking below the separation is unknown. Although these sections would have been subjected to similar loads, the same extent of gross radial distortion (yielding) as described above is not likely due to the anticipated brittleness of tube sections exposed to radiant heating within the firebox.

The final resting place of these five tubes, the reported single bang, the full thickness of the fracture faces especially in regions of gross radial deformation and the distortion direction conclusively indicated that failure was due to "simultaneous", sudden, high internal pressure loads applied near the upper end of each assembly.

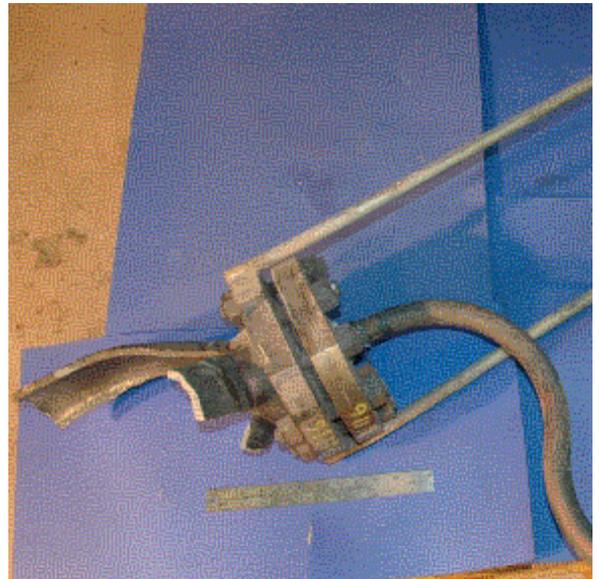
**Photograph 8** Tube #116 removed from furnace

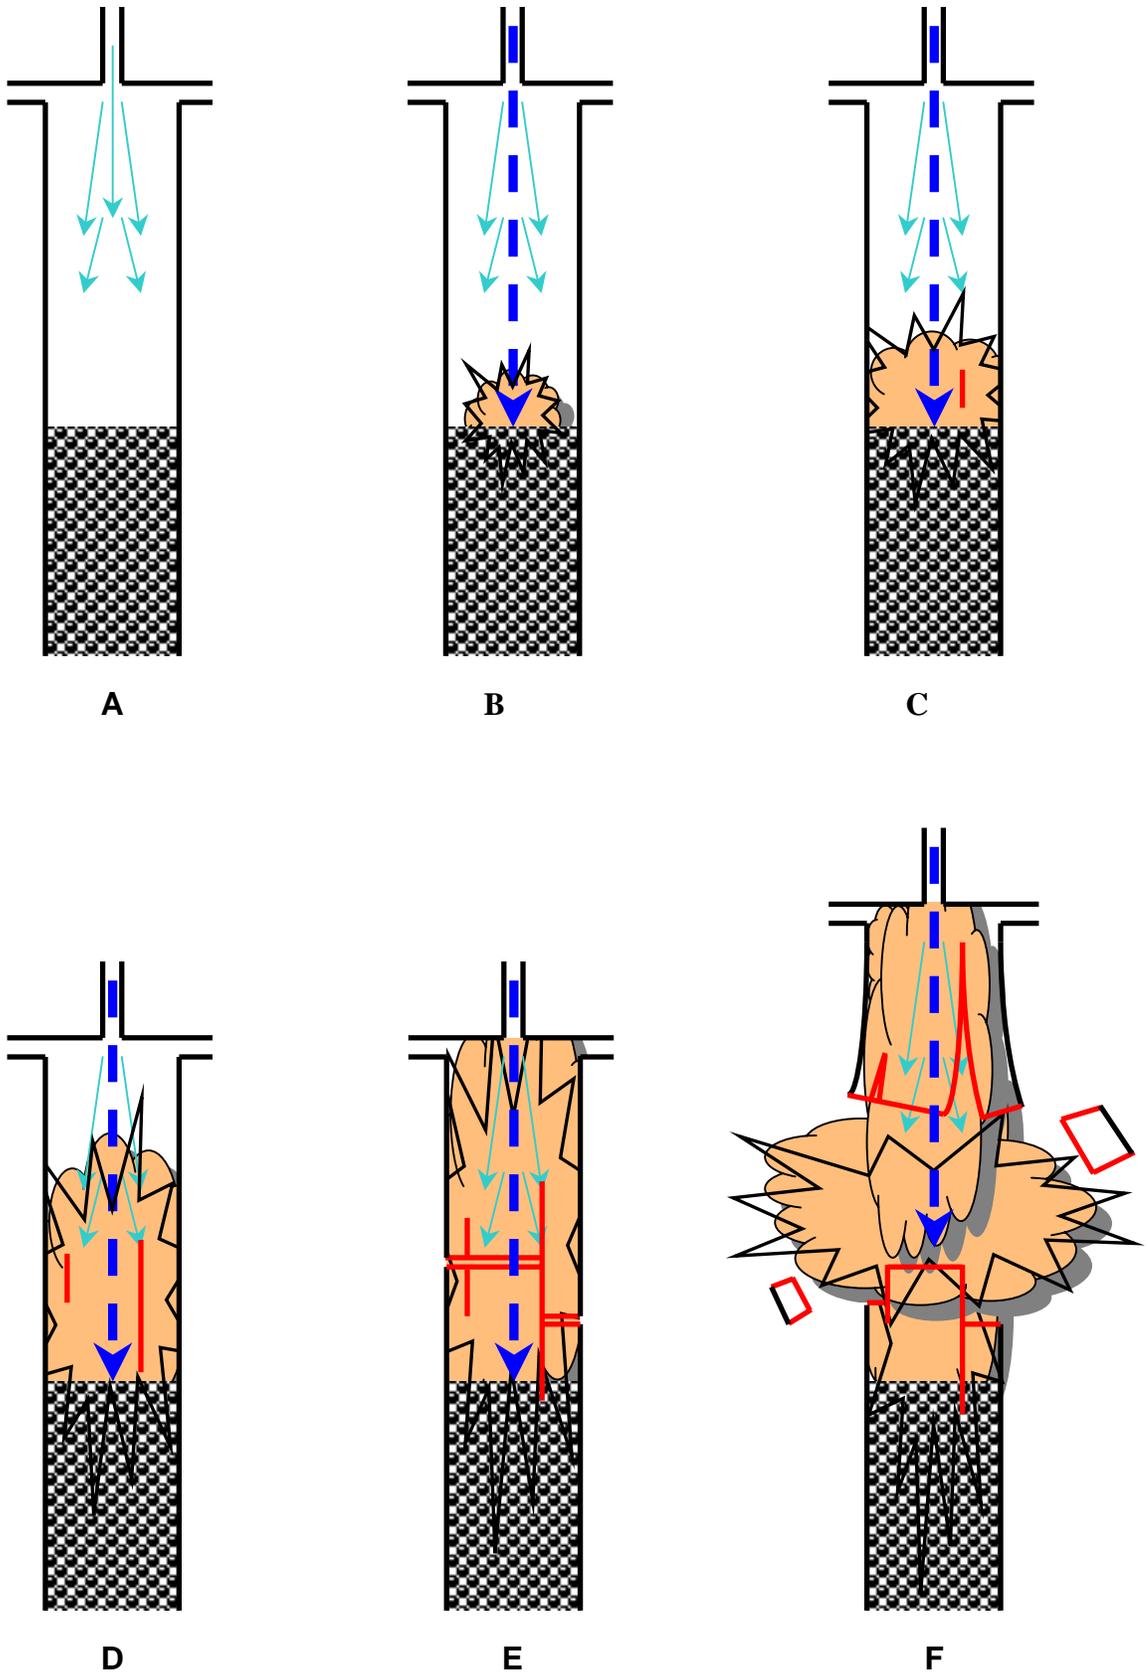
Diagram 1 Sequential Representation of Impulse

The steam flow enters the hot, catalyst filled tube through the inlet pigtail and would be normally passed down through the catalyst and exit via the outlet header. Entrained water impinges on hot catalyst and possibly on the pipe wall and “instantly” flashes. This produced an extreme local pressure excursion and shock wave. The shock wave reached the pipe wall and initiated longitudinal cracking due to a hoop stress shock. It then progressed upward at sonic speed (~24,000 in/sec in 320°C steam at 75 psia) and downward (although impeded by random reflection at catalyst surfaces). Longitudinal cracking further extended due to the advancing hoop stress shock.

The shock wave reached the flange about one millisecond after water flashed at the catalyst and imparted an axial shock load on the tube. This resulted in sudden lateral brittle fractures progressing from the inside out and the upper and lower tube sections separate.

The now unconstrained upper tube end is launched out of the furnace by the extreme internal pressure. This also causes radial displacement of the free tube end segments. In areas of normally brittle material (hot areas within the furnace), high bending loads result in horizontal brittle fractures and the generation of shrapnel. Ductile material near the flange is able to yield without fracturing and produces a “banana peel” effect immediately below the flange assembly.

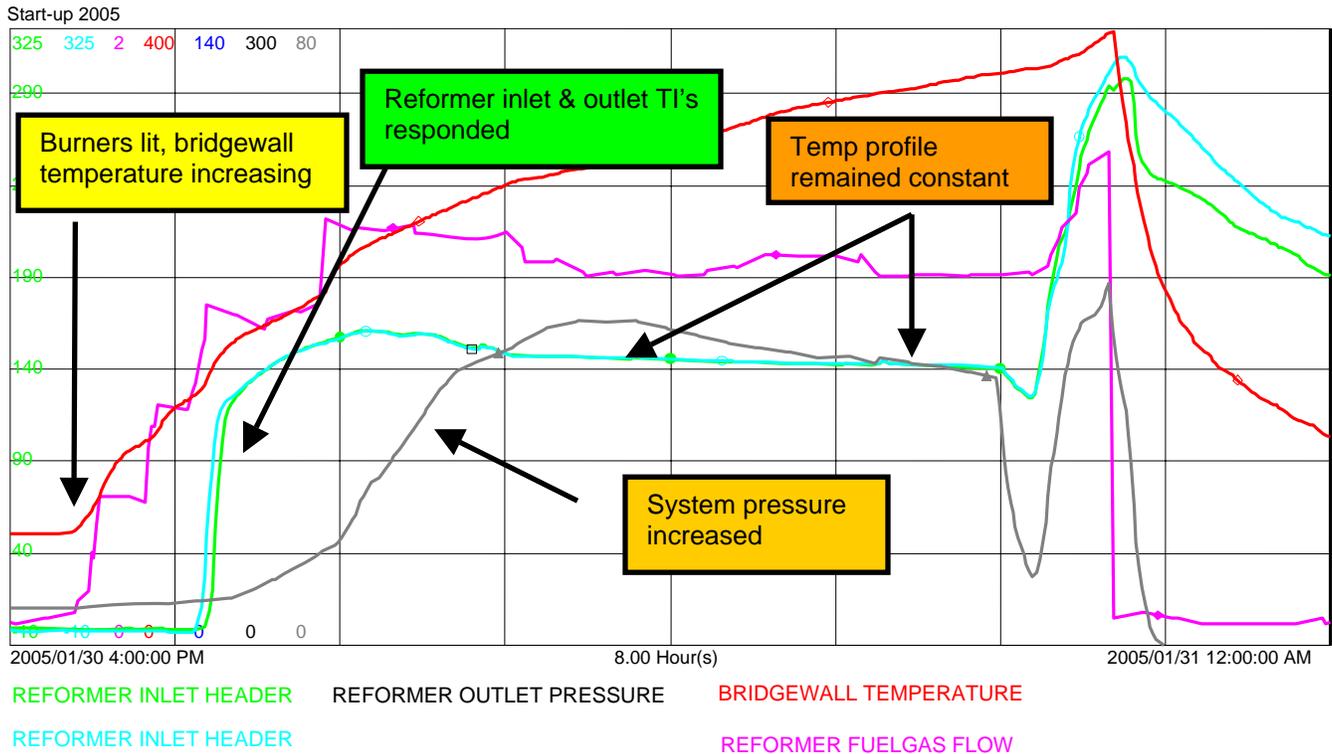
The startup procedure did take into consideration the need to have the reformer furnace feed system water free and steps are included to ensure that any water would be either drained from the system or evaporated as steam during heat up. Shortly after gas burner lighting commenced, the reformer mixed-feed temperatures began a rapid ascent before settling at ~143°C (290°F). At the same time, but at a slower rate, the reformer outlet header temperature began to increase and eventually settled at approximately the same temp as the reformer inlet. However, no flow was going through the feed line and reformer radiant tubes. The process piping system had been purged with nitrogen and the process down stream of the reformer furnace was still isolated. The system pressure, also began to increase to ~40 psig. (Saturation temperature of 40-psig steam is 141°C.)

The temperature of the reformer inlet and outlet remained constant at ~143-146°C, even though the portions of the radiant tubes in firebox were approximately 350°C. A constant temperature profile indicated that water was still present since steam generation occurs in equilibrium with water at a constant temperature, until all water is vaporized.

The investigation team calculated that after the Induced and forced draft fans were commissioned, the mixed feed and superheater coils gave up approximately 56MBtu of heat from 0900 to 1630 hrs, as evidenced by the temperature rise. This corresponds with the production of approximately 30,000 lbs of condensate over the 7-hr period. Further from 19:00 to 22:00 hrs, the mixed feed preheat coil absorbed approximately 14.6MBtu of heat. This would be equivalent to producing approximately 18,000 lbs of steam over this 3-hour period.

The following graph depicts these key process conditions prior to the incident.

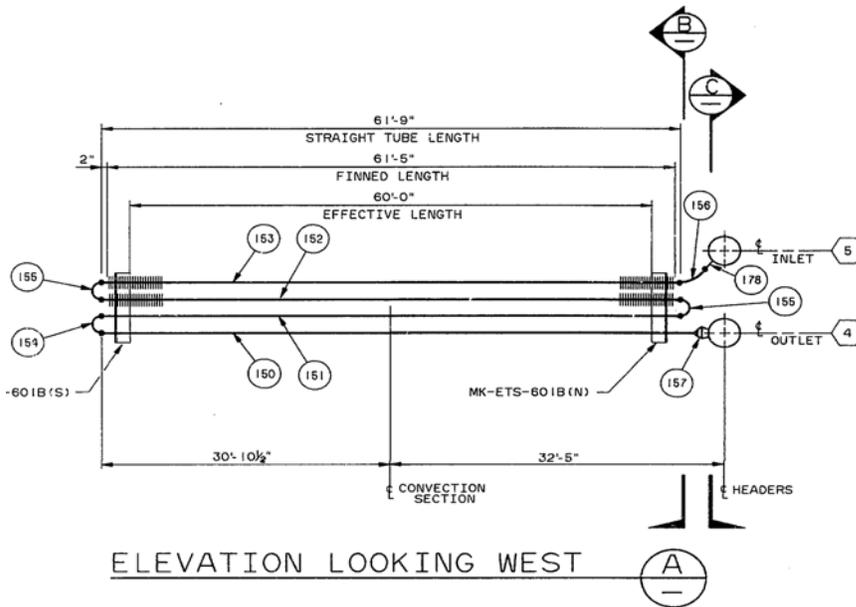
Diagram 2 Detail of Mixed Feed Preheat Coil

The most likely source of water accumulation would be in the mixed feed preheat coil for two reasons. The inlet header to this coil will not fully self-drain and the tubes had become slightly bowed over time.

The system was designed with low point drains to facilitate water removal however these were found to be inadequate in both location and size. The fact

that the mixed feed pre-heat coil was not self-draining was unknown prior to the incident.

After a thorough review of the entire reformer furnace feed system was completed, existing drains were increased in size and others added to ensure the entire feed system could be drained.
