# Lessons Learned From an Unusual Hydrogen Reformer Furnace Failure

Mike Rogers, Syncrude Canada Ltd. Fort McMurray Alberta Canada

On January 30, 2005 a high-energy pressure impulse occurred within several radiant tubes of a steam/ methane reformer furnace during startup after a partial shutdown. This impulse caused the simultaneous rupture of 5 tubes with sufficient force to eject portions of the tubes out through the roof of the furnace. All of the failures occurred near the inlet of each tube in the headspace above the catalyst and the 5 tubes were clustered toward the centre of the furnace in four rows.

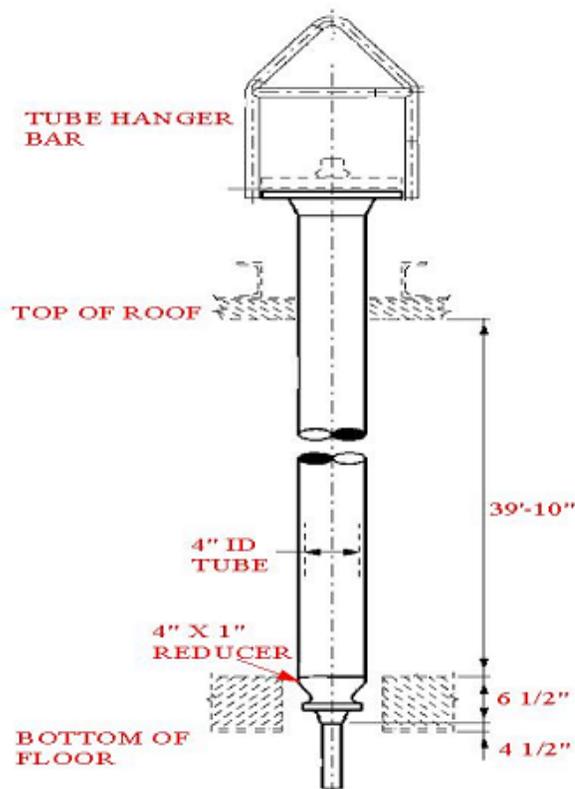
**Figure 1 General tube arrangement**

The tubes are mounted vertically with the flow entering in the top and exiting at the bottom. Each tube has a 10.2cm (4") ID and is 12 meters (39'10") long containing 102 cubic decimeters (3.6 Ft<sup>3</sup>) of nickel alumina (NiAl) catalyst. Figure 1 provides the general layout of a radiant tube.
